PLAY AREA SAFETY INSPECTION REPORT

Fringford Parish Council

25 July 2017

Site Owner : **Fringford Parish Council**
Site Name : Fringford PC - Village Green
Date of Inspection : 25 July 2017
Inspected by : Rachel Adams

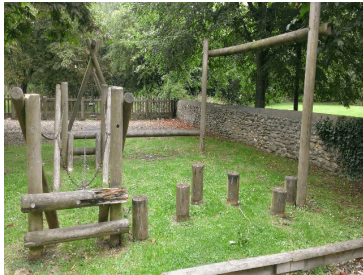
Balance Trail

Risk Level : Low
Risk Score : 4

Surfacing EN Compliance - Grass

The surface meets with the requirements of the relevant standard where this may be tested on site without dismantling or destruction.

Comments, action or control required	Risk Level	Risk Score †
Equipment		
Finding : Some chain wear	Low	6
Task : Monitor for further deterioration and replace at 40% wear		
Finding : Item - Parts Missing	Very Low	2
Finding Date : 25/07/2017

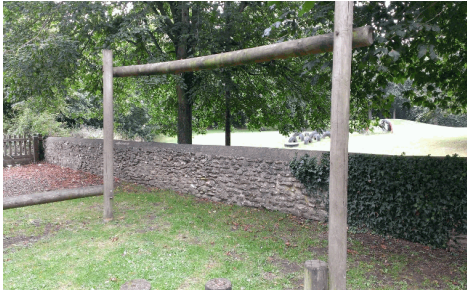
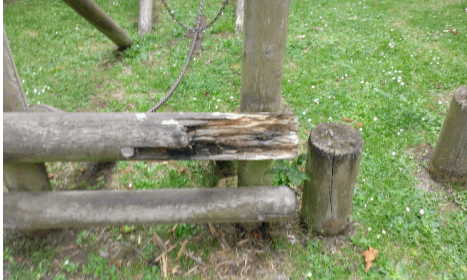
Task : No action given the risk assessment		
Finding : There is decay to timber components which may affect structural integrity . Due to the increased problem of timber rot, especially in posts in contact with the ground, we do not recommend replacing rotten supports with timber posts which are directly set in the ground.	Medium	10

Task :	Replace decayed components where possible, and plan replacement of item. Check on a routine basis, especially at ground or foundation level	Low	6
Finding :	Item - Bolt(s) loose		
Notes :	Eye bolts.		
Task :	Tighten loose fixtures & fittings		
Surfacing - Grass			
No remedial maintenance work is required at this time.			
The overall risk for this item at the time of inspection:		Medium	10
‡ For Risk Score see Report Notes

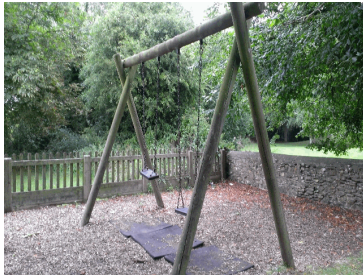
Swing - Junior - 1 Bay 2 Seat

Risk Level : Low
Risk Score : 5

Surfacing EN Compliance - Bark

The surface fails to meet the requirement of the relevant standard.

Comments, action or control required		Risk Level	Risk Score ‡
Equipment			
<p>Finding : There is decay to timber components which may affect structural integrity . Due to the increased problem of timber rot, especially in posts in contact with the ground, we do not recommend replacing rotten supports with timber posts which are directly set in the ground.</p> <p>Finding Date : 25/07/2017</p> <p>Notes : Support legs. Site scheduled for replacement - remove seats and chains until site is removed.</p>	Medium	10

<p>Task : Replace decayed components where possible, and plan replacement of item. Check on a routine basis, especially at ground or foundation level</p> <p>Finding : Monitor</p> <p>Notes : Damage to top bar.</p> <p>Task : Monitor and check on a routine basis</p>	Low	7	
Surfacing - Bark			
<p>Finding : Surface - Loose Fill - Level Low - FHF over 600 mm</p> <p>Task : Top up depth of loose fill to 300 mm minimum</p>	Medium	8

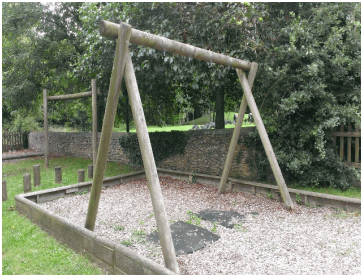
Swing - Toddler - 1 Bay 2 Seat

Risk Level : Very Low
Risk Score : 3

Surfacing EN Compliance - Bark

The surface fails to meet the requirement of the relevant standard.

Comments, action or control required		Risk Level	Risk Score ‡
Equipment			
Finding :	There is decay to timber components which may affect structural integrity . Due to the increased problem of timber rot, especially in posts in contact with the ground, we do not recommend replacing rotten supports with timber posts which are directly set in the ground.	Medium	8
Task :	Replace decayed components where possible, and plan replacement of item. Check on a routine basis, especially at ground or foundation level		
Finding :	Swing - Seats - Missing	Very Low	2
Finding Date :	25/07/2017		
Task :	No action given the risk assessment		
Surfacing - Bark			
Finding :	There is decay to timber components which may affect structural integrity . Due to the increased problem of timber rot, especially in posts in contact with the ground, we do not recommend replacing rotten supports with timber posts which are directly set in the ground.	Low	7

Notes :	Wooden retainer.		
Task :	Replace decayed components where possible, and plan replacement of item. Check on a routine basis, especially at ground or foundation level		
Finding :	Surface - Loose Fill - Level Low - FHF over 600 mm	Low	6
Task :	Top up depth of loose fill to 300 mm minimum		
The overall risk for this item at the time of inspection: ‡ For Risk Score see Report Notes		Medium	8
