PLAY AREA SAFETY INSPECTION REPORT

Fringford Parish Council

25 July 2017

Site Owner : **Fringford Parish Council**
Site Name : Fringford PC - Village Green
Date of Inspection : 25 July 2017
Inspected by : Rachel Adams

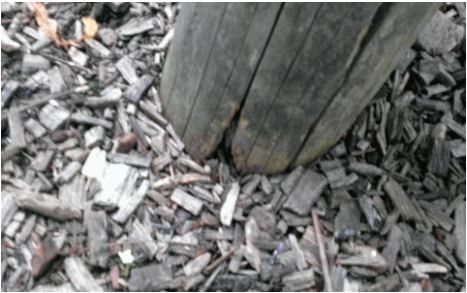
Comments, action or control required		Risk Level	Risk Score ‡
Equipment			
<p>Finding : There is decay to timber components which may affect structural integrity . Due to the increased problem of timber rot, especially in posts in contact with the ground, we do not recommend replacing rotten supports with timber posts which are directly set in the ground.</p> <p>Finding Date : 25/07/2017</p> <p>Notes : Support legs. Site scheduled for replacement - remove seats and chains until site is removed.</p>	Medium	10

<p>Task : Replace decayed components where possible, and plan replacement of item. Check on a routine basis, especially at ground or foundation level</p> <p>Finding : Monitor</p> <p>Notes : Damage to top bar.</p> <p>Task : Monitor and check on a routine basis</p>	Low	7	
Surfacing - Bark			
<p>Finding : Surface - Loose Fill - Level Low - FHF over 600 mm</p> <p>Task : Top up depth of loose fill to 300 mm minimum</p>	Medium	8
